## Case Study 4:

# Warm Water System Disinfection

## Warm Water Loops in Aged Care and Institutional Facilities.

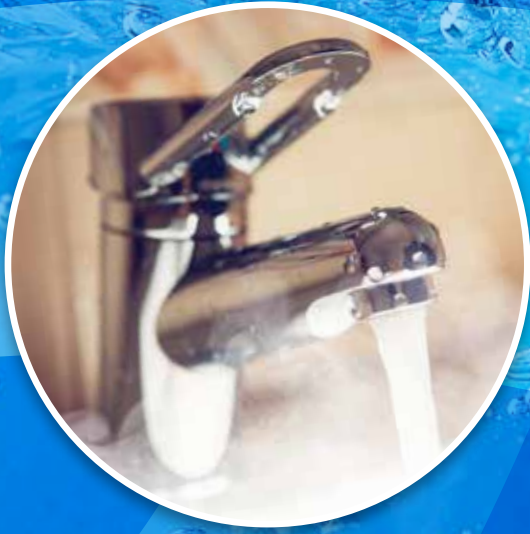
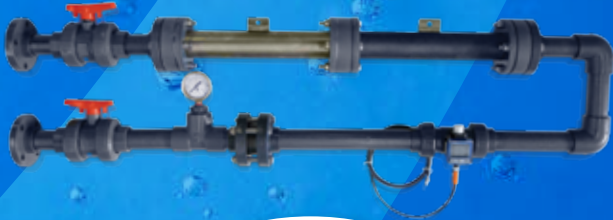
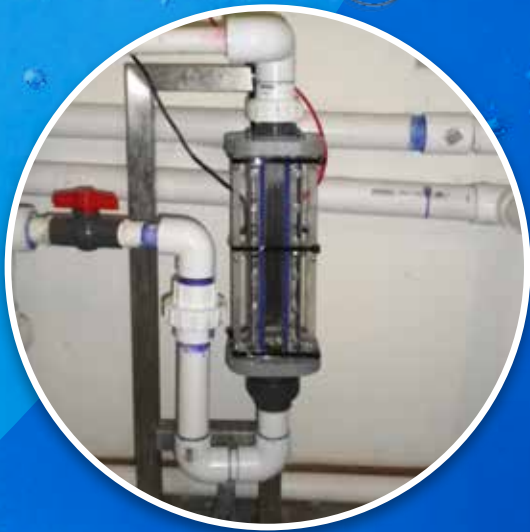
This Gen 2 spa installation is typical of how a Warm Water Loop Installation would be carried out.

The system can be retro fitted into the circulation loop which constantly supplies a controlled dose of chlorine into the hot water loop ensuring disinfected water delivered to all taps and outlets. The presence of free chlorine removes any biofilm build up further reducing the possibility of legionella being harboured in the system. The Hydro-dis® technology as a Dual Disinfection System is compliant with the Code of Practice for the Control of Legionella.
